# Twinax cables certification matrix for Cisco<sup>®</sup> Nexus 2000 and Nexus 5000 Series Switches

**Revised:** February, 2012

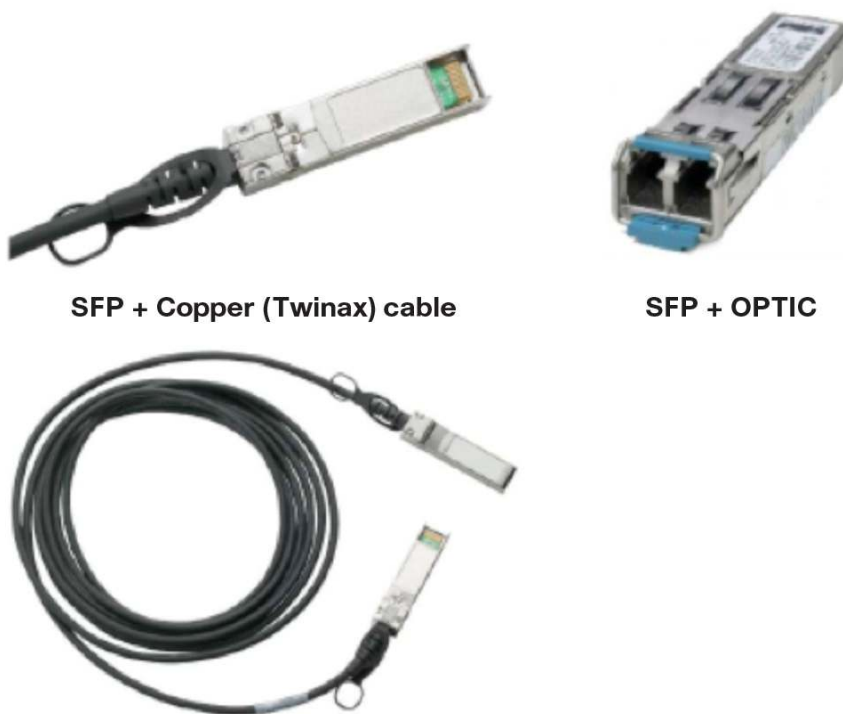
**Figure 1.** 10GBase-SFP Modules

Both Nexus 2000 and Nexus 5000 series switches use SFP+ form-factor for 10GE interconnects, which is capable of providing 10GE support in either copper or fiber media.
